PROWASH

iVac TURBO – VAC FILTER BAG TENSION

May 2021

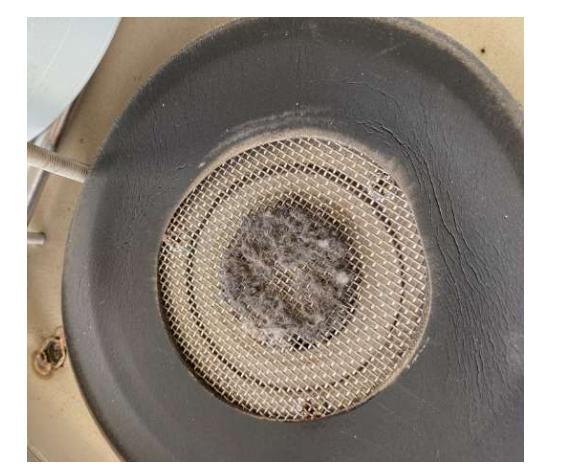
It has been brought to our attention that the mesh on the vacuum motor installed in the Prowash iVac TURBO can block up and can cause the vacuum motor to overheat.

Vacuum motor mesh blocked

The mesh filter on this style of vacuum motor is an important safety feature that prevents anything from entering the motor that may cause damage, in particular the sharp fast moving vacuum impellor. The vacuum motor relies on air flow to self-cool so it is vital that the mesh filter is inspected regularly and cleaned/cleared of dust particles as required.

In some instances, we have seen vacuum motors losing suction, overheating, drawing too much current and tripping the circuit breakers. If you have a Prowash iVac TURBO the recommended routine maintenance includes cleaning out the filter bags (and washing regularly) and inspecting the mesh under the vacuum motors to ensure they are all free of dust particles or anything that could be blocking the mesh. Even more importantly you must ensure the vacuum filter bags are installed correctly to prevent this from happening prematurely. Loose filter bags will allow the dust to escape past the bag and then get trapped on the motor mesh.

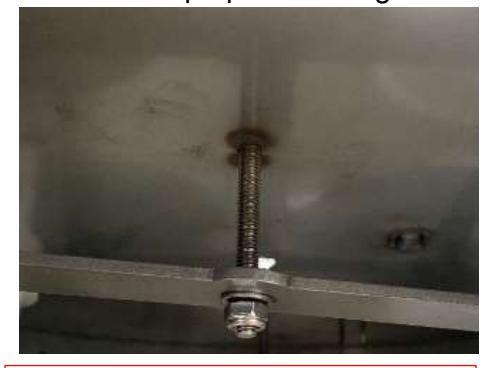
If the filter bag is not installed correctly, it allows an air gap at the bottom of the filter bag and dust will escape past the bag and not through it.

Top loose – the filter bags have no tension

Filter bags should be installed firmly at both top and bottom to ensure air and dust flow through them. The filter bags are the first stop in filtering the air entering the vacuum. If the filter bags are not installed correctly the dust particles can collect on the vacuum motor mesh.

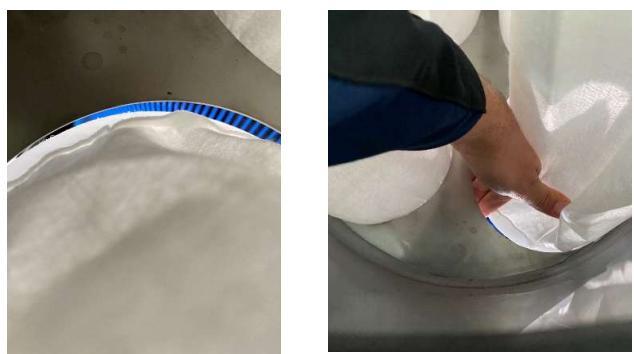
No tension leads to an air gap

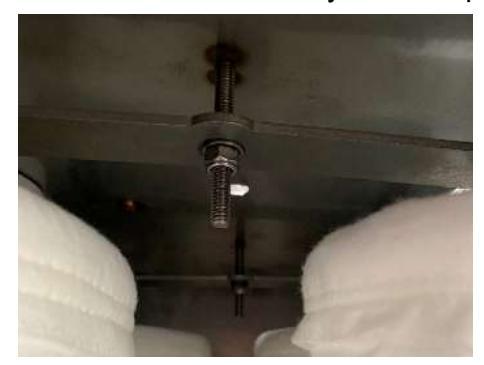
Top tightened – gives the filter bags good tight tension

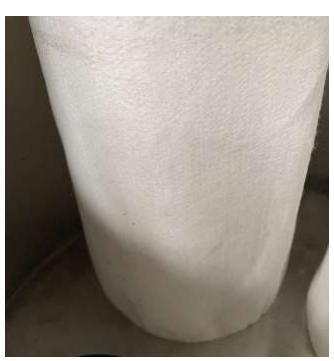
Good tension means no gap at the bottom

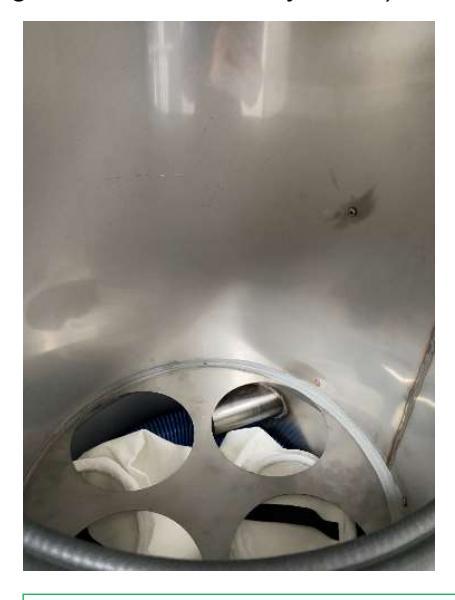
Grey silicone seal - ensuring all air travels through the filter

If you find dust on the mesh, check filter bags but also check that centre baffle is sealed with silicone and has no air gap around the outside. From the factory the iVac TURBO has a silicone seal all around the centre baffle.
